MULTI-FAN BLOWER DOOR TESTING LESSONS LEARNED

Presented by: Mike Barcik & Laura Capps, Southface
mikeb@southface.org laura@southface.org

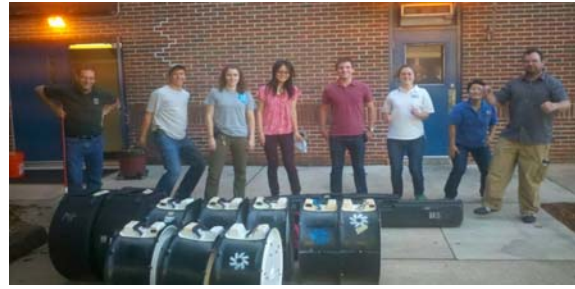
BIG PICTURE TEST PROCESS

- Follow a protocol
- Map equipment location
- Pre-test planning meeting of all participants – assign roles/stations
- Gather all equipment – confirm that it works
- Arrive, install equipment & prep building for testing
- Use software to perform testing
- Diagnose leaks and document results

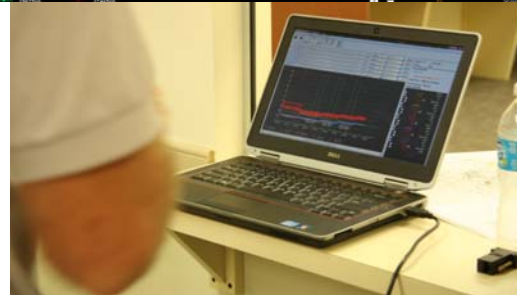
BD TESTING COMMERCIAL BUILDINGS

- Configure hardware and run software
- Prompts for baseline(s)
- Prompts for data recording periods
- Graphs results

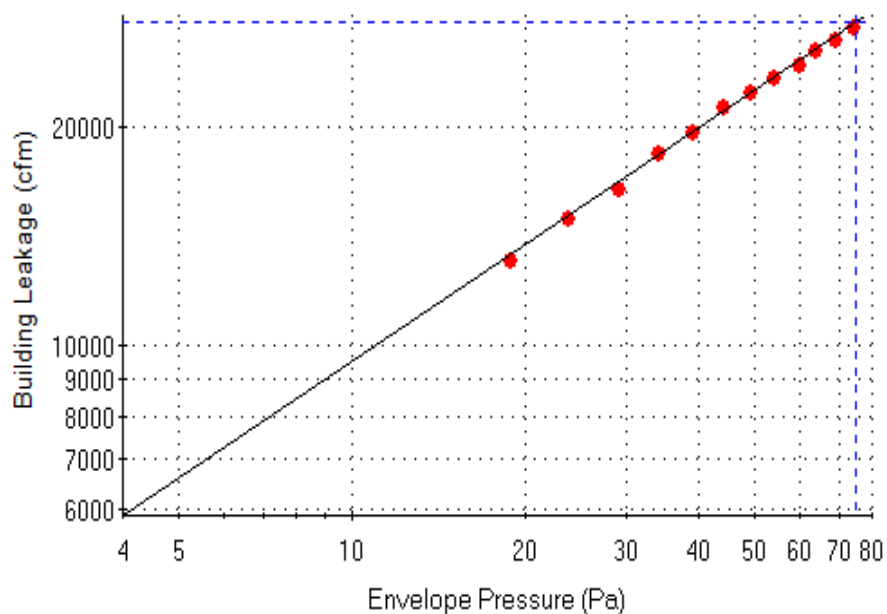
A BETTER WAY TO PLOT THE RESULTS

- Data becomes easier to read when plotted on logarithmic scale
- Curve allows leakage estimation at any pressure (e.g. 4 Pa)

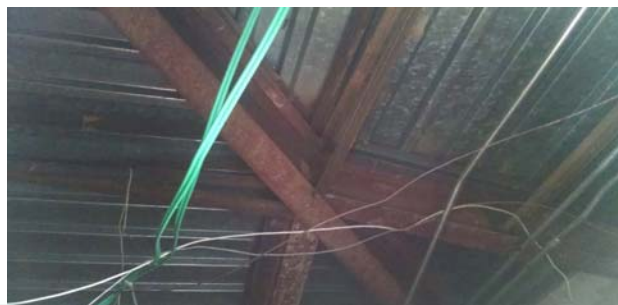
BD REVEALS COMMON LEAKAGE PATHWAYS

- Utility Chases
- Metal Roof Decking
- Gabled Roof Junctions
- Mechanical RTU Penetrations
- Roof Membrane Connections

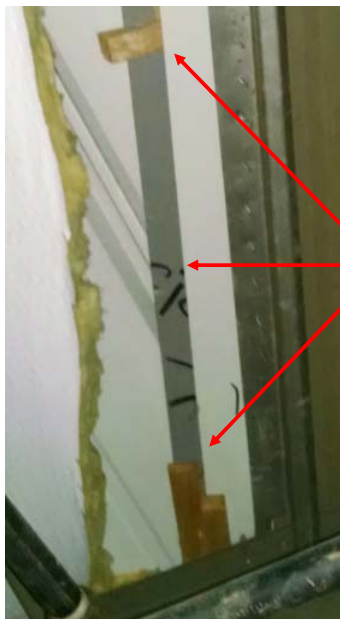
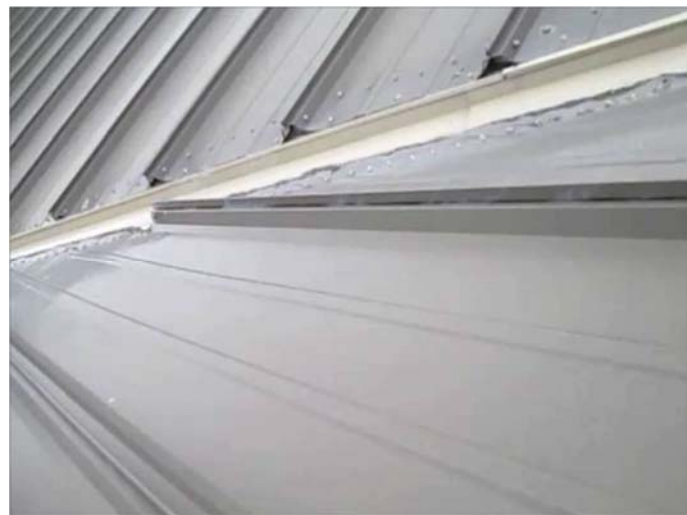
METAL BUILDING ROOF

Shims

Roof above shims

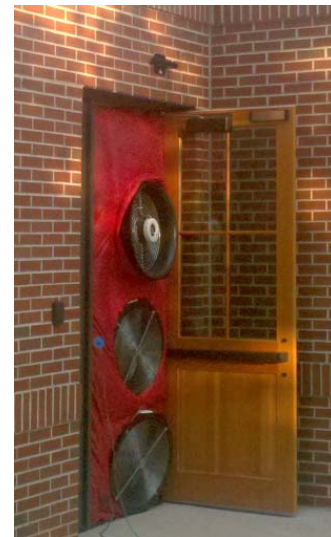
BUILDING ENVELOPE

Air Leakage Testing

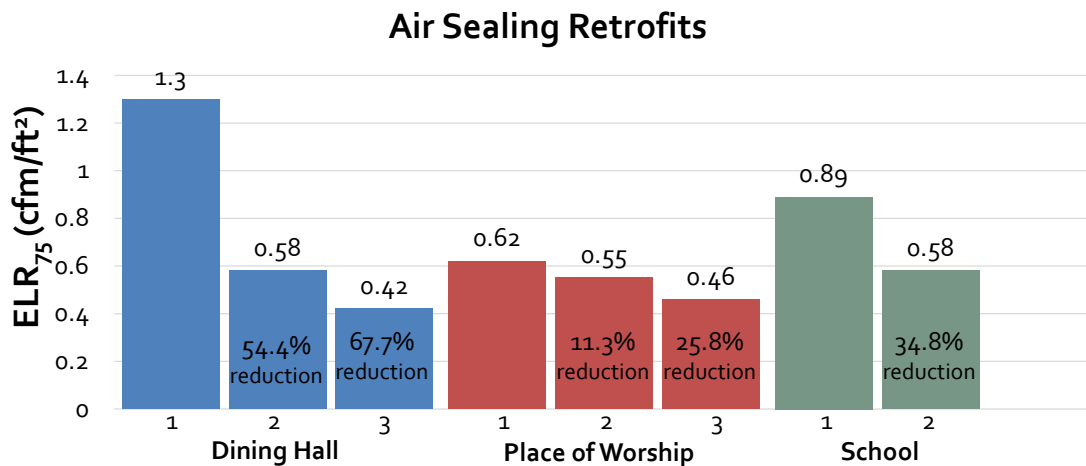
AIR SEALING RETROFITS

Air leakage of existing buildings can be substantially reduced with **spray foam**

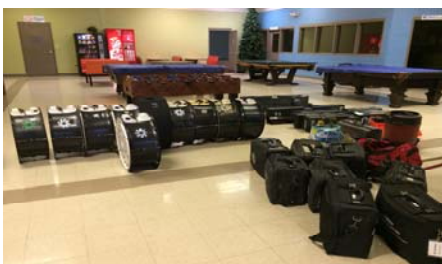
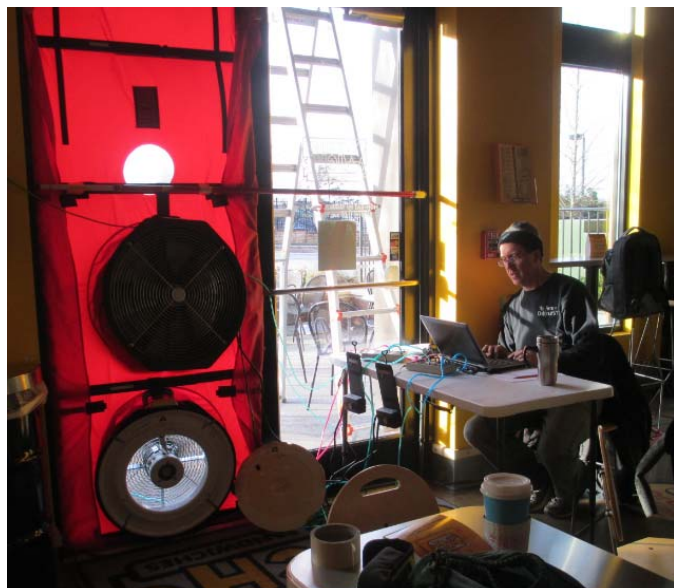
- Reinforce masking
- Duplicate fans
- Foam insulation tubes
- Theatrical fog machine, flex duct and a really long pole
- Site communication
