**2016  
Conference**

# Concealed Insulation Defects

SHOULD YOU WORRY ABOUT THINGS YOU CANNOT  
SEE?

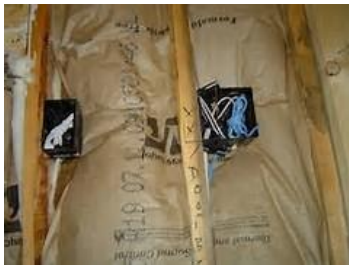
Piping and Wiring

- Concealed air gap behind outlet boxes, wiring and piping
- Visible air gap when insulation is compressed behind wiring and piping

- Improper trimming of batt
- Hasty installation procedures

- Missing insulation
- Compressed insulation

- Installer training to cut and fill batts into these areas

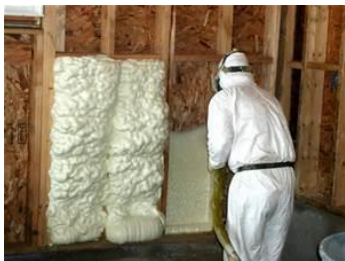
**concealed** rear gap from rising foam dragging along side of stud;

Poor wetting of foam on side of stud creates weak bond that *MAY* eventually release, causing foam to shrink away from stud

- Concealed air gap between studs and sheathing
- Can occur with ccSPF or ocSPF

- Improper spray pattern (ocSPF)
- Improper application technique

- Poor or zero adhesion to stud wall
- May result in delamination and shrinkage (ccSPF)

Use "picture-frame" spray technique to create fillet and wet-out side of framing

- Proper spray pattern (ocSPF)
- Use of "picture-framing" technique

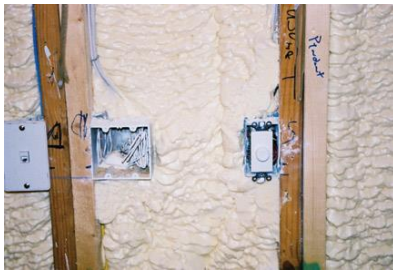
Junction/Outlet Box

- Concealed air gap between junction box and sheathing
- Can occur with ccSPF or ocSPF
- Inspect/probe wire openings of outlet box

- Improper application
- Hasty installation procedures

- Missing insulation R-value
- Air leakage if box is mounted on a stud with a sheathing seam

- Installer training
- Can inject can foam into outlet box openings

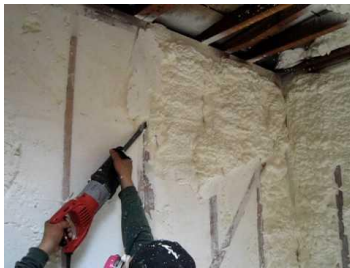
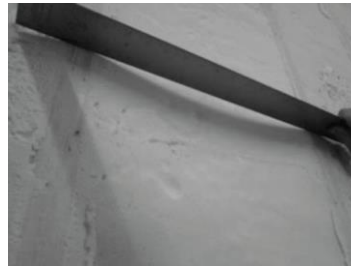
Concave Face Trimming

- Visible air gap between insulation and gypsum board
- Can occur with ocSPF during trimming

- Flexible trimming saw with too much pressure

- Missing insulation R-value (?)

- Modify trimming technique
- Use different trimming equipment

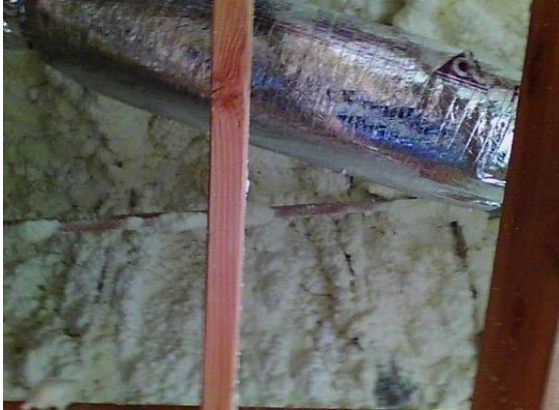
## IR Imaging

Emphasizes surface defects (cold spots not warmed by interior surface convection)

May not show hidden interior defects

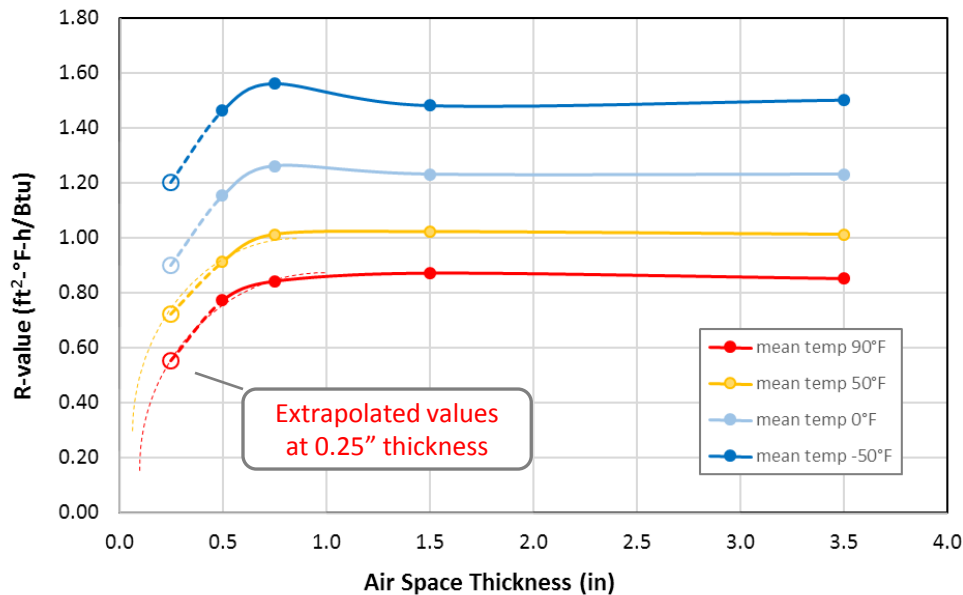
$\epsilon_{\text{eff}} = 0.82$   
 $\Delta T = 10^\circ\text{F}$

## 2005 ASHRAE Handbook of Fundamentals, Ch 25 Table 3 (Robinson et al. 1954)

- R-value versus thickness of air gap (0.5" to 3.5") for heat flow in different directions
- Function of mean air gap temperature and temperature difference, emissivity of gap surfaces
- Assumes air gap is sealed against air leakage

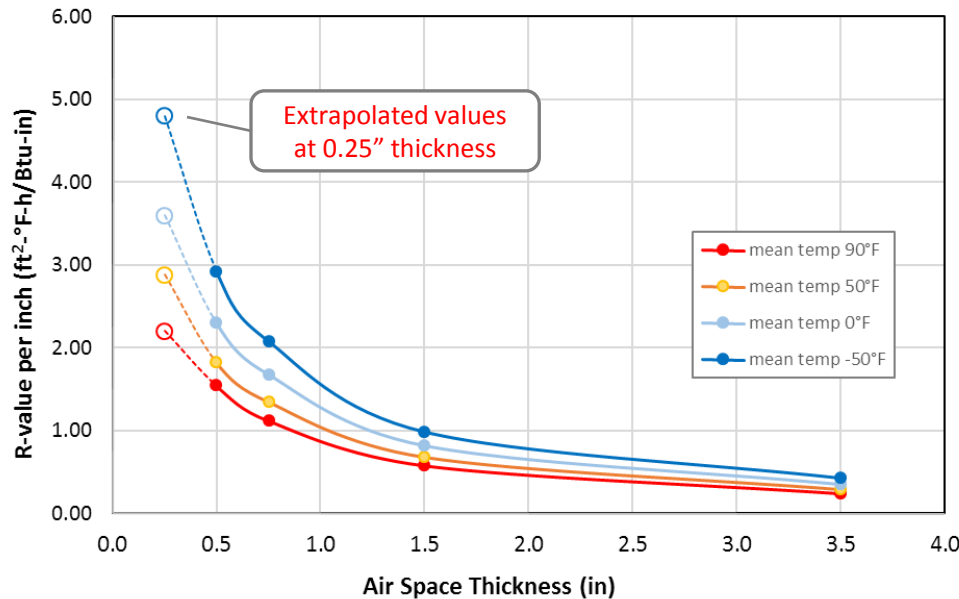
$$\epsilon_{\text{eff}} = 0.82$$
$$\Delta T = 10^\circ\text{F}$$

## Convert to R-value per inch thickness versus gap thickness

- R-value/inch increase with decreasing gap thickness, approaching that of insulation as gap size decreases below  $\frac{1}{2}$ "
- Do small air gaps in the insulation actually reduce R-value?

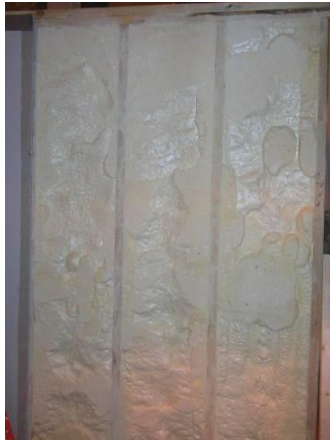
## SPFA-funded C1363 Testing at ATI (2007)

- ocSPF was applied to nearly fill the cavity and then trimmed (see photo below)
- Under-filled area about 40-50% of cavity surface
- Average under-fill was about 0.35"
- Full-cavity R-value:  $R3.6/\text{inch} \times 3.5'' = R12.6$
- C1363 measured R-value: **R12.35**
- Calculated R-value for R air-gap=0:
  - $R3.6/\text{inch} \times (3.5-0.35) = R11.34$  over half cavity area
  - $R11.34 * 50\% + R12.6 * 50\% = R11.95$
- Calculated R-value for R air-gap=R2.5/inch:
  - $R3.6/\text{inch} \times (3.5-0.35) + R2.5/\text{inch} \times (0.35) = R12.21$  over half cavity area
  - $R12.21 * 50\% + R12.6 * 50\% = R12.41$

Small air gap has measureable R-value and should not be assumed zero.
